**Flood Control Project Maintenance  
Levee Inspections**

**Fall 2015 Levee Maintenance Deficiency Summary Report**

**San Joaquin River Basin**

**Reclamation District No. 2031 Elliot**

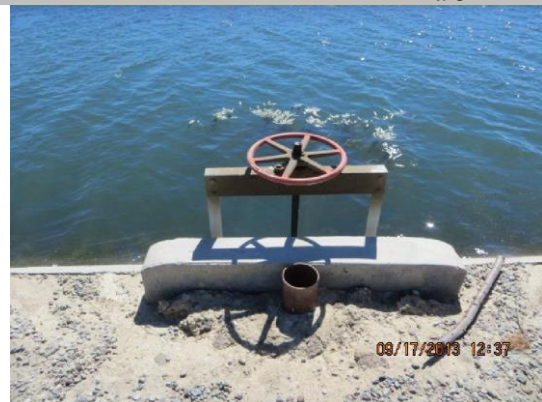
Photo 1 of 2 : UCIP\_FA\_2015\_1886.jpg

LM Start	5.63	Rating **	M	Issue No.	973
LM End	5.63	Issue Type +	En	Location *	LS
Category	Supplemental			GPS Latitude/Longitude	
				Start	End
Item	DWR UCIP Field Study			37.630779 °	37.630779 °
				-121.165402 °	-121.165402 °
DWR ID					
Action/Comments					
Inspector Comments: FS_ID:22873 DS_ID:24677 EP_NO: N/A FS_HLM: 5.69 Repair Type: Non-Urgent Crossing Status: Found UCIP Comments: No permit identified for this crossing. FIELD_STRUCT_DESC: 24-inch PVC irrigation pipeline through levee 5.0-feet below crown. Slide gate at waterward shoulder. 6-inch steel riser on WS shoulder. FS Date: 09/17/2013

Slide gate and vent at concrete headwall on canal at WS shoulder.

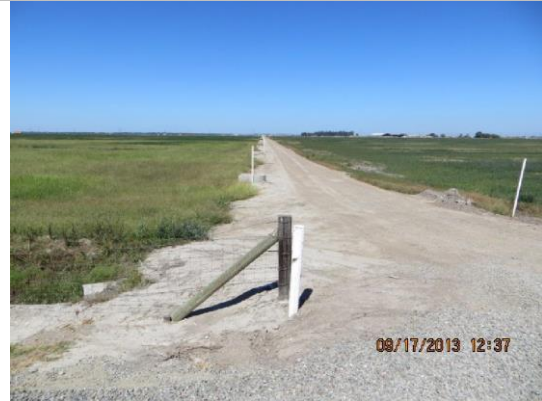
Photo 2 of 2 : UCIP\_FA\_2015\_1887.jpg

Concrete turnouts visible off LS toe along road.

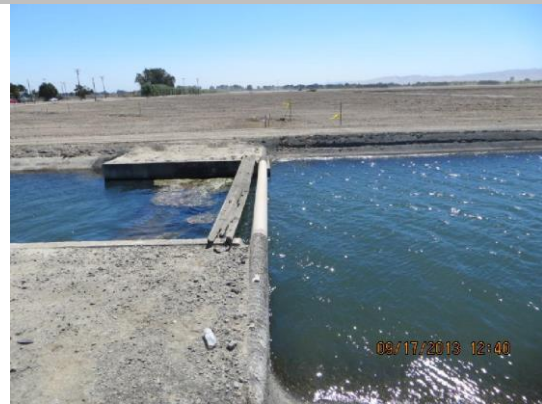
Photo 1 of 2 : UCIP\_FA\_2015\_1688.jpg

Gasline visible at crossing.

Action/Comments					
Inspector Comments: FS_ID:20745					
DS_ID:20503					
EP_NO: N/A					
FS_HLM: 5.993					
Repair Type: Non-Urgent					
Crossing Status: Found					
UCIP Comments: Gasline may not have enough cover.					
FIELD_STRUCT_DESC: 8-inch gas line through the levee 1.0-foot below the crown. Originally included in the 1968 O&M manual. Sign on LS toe, pipe visible at canal.					
FS Date: 09/17/2013

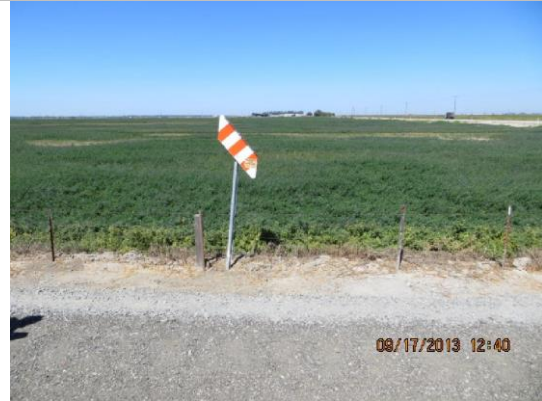
Photo 2 of 2 : UCIP\_FA\_2015\_1689.jpg

Gasline marker on LS toe.
